OAKLAND AIR CONTROL, HELPING WORCESTER CATHEDRAL'S ORGAN STAY IN TUNE!

Worcester Cathedral

HVAC Installation

Historic building heating,
cooling and ventilation

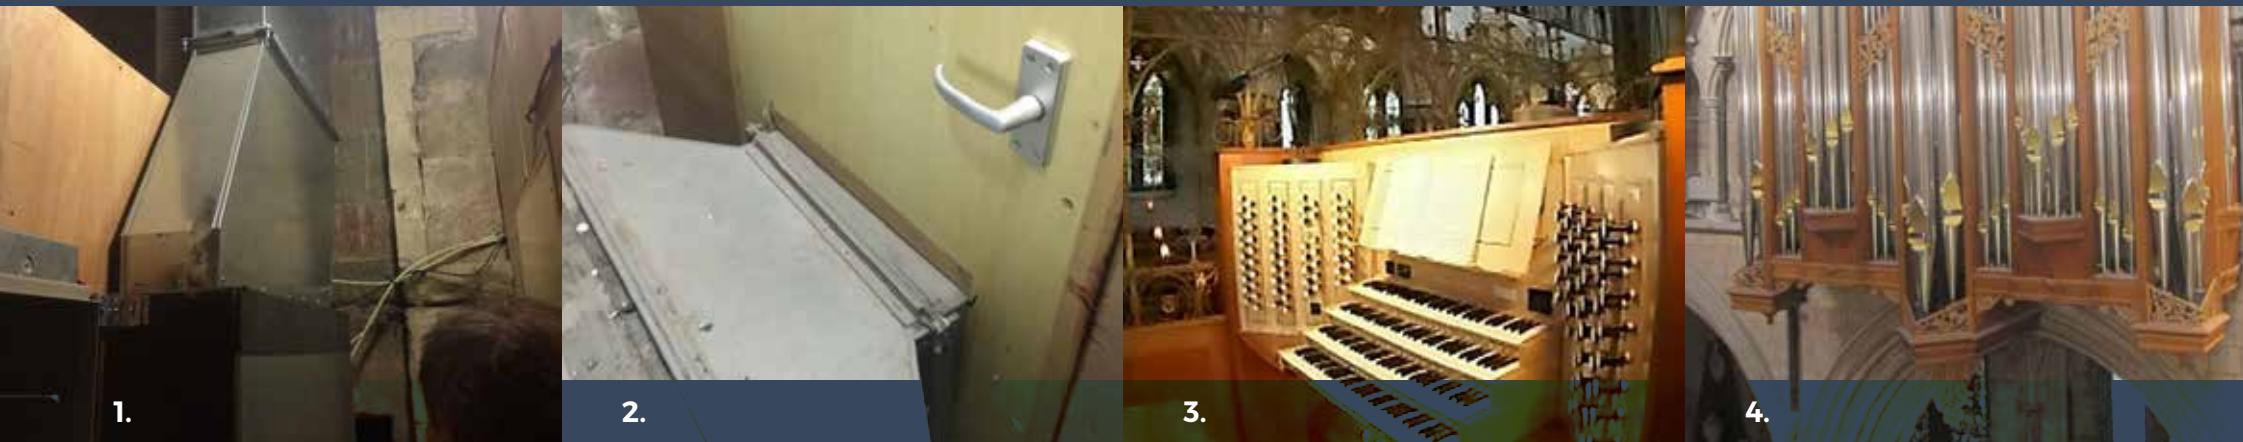
1. Wrongly installed unit!
2. Previous ductwork installed through door!
3. A view of the organ from inside the Cathedral
4. A view of the pipes from inside the Cathedral

The existing void mounted heat pump unit had been installed in the vertical plane (see photo 1.) instead of horizontally meaning the drip tray (which catches condensate dripping from the coil when in cooling mode) was also vertical (therefore incapable of catching anything!). Consequently, the condensate dripped onto the filters, wetting them out and blocking airflow, and water damaged the unit's PCB. The condensate then pooled in the bottom of the ductwork which stopped the unit.

Others were asked to attend the problem and their solution was to drill a hole in the lower ductwork thereby allowing the condensate to drip onto an internal roof which was not water proof!

The installation also had unclipped pipework, no lagging on any of the ductwork outside the Pipe room, and the ductwork had been routed through a door (see photo 2.) rendering access to the unit for maintenance very difficult. Eventually the unit failed completely.

Here is a picture showing how the previous installations return ductwork blocked the door, meaning that access to the unit for maintenance purposes could only be gained via a hatch in the roof!

- The stripping out and removal from site of the existing, failed AC and ductwork
- The supply and fitting of a new Mitsubishi Ducted Heat Pump Unit. Mitsubishi Electric Mr Slim Void Mount PEAD RP60JAQ with outdoor unit PUHZ ZRP60VHA
- The supply and fitting of all new ductwork both in the Plant area and in the organ loft (High main ducting run with Low Level 'dropper' ducts)
- The insulation of all ductwork
- To Supply and Fitting of a new 4" Fresh Air Supply Fan to the return Ducting to positively pressurise the Organ loft
- Supply and installation of a new Trend Controller
- To connection to Network Point and configuration for remote control and graph viewing
- On-site training on Web based controls

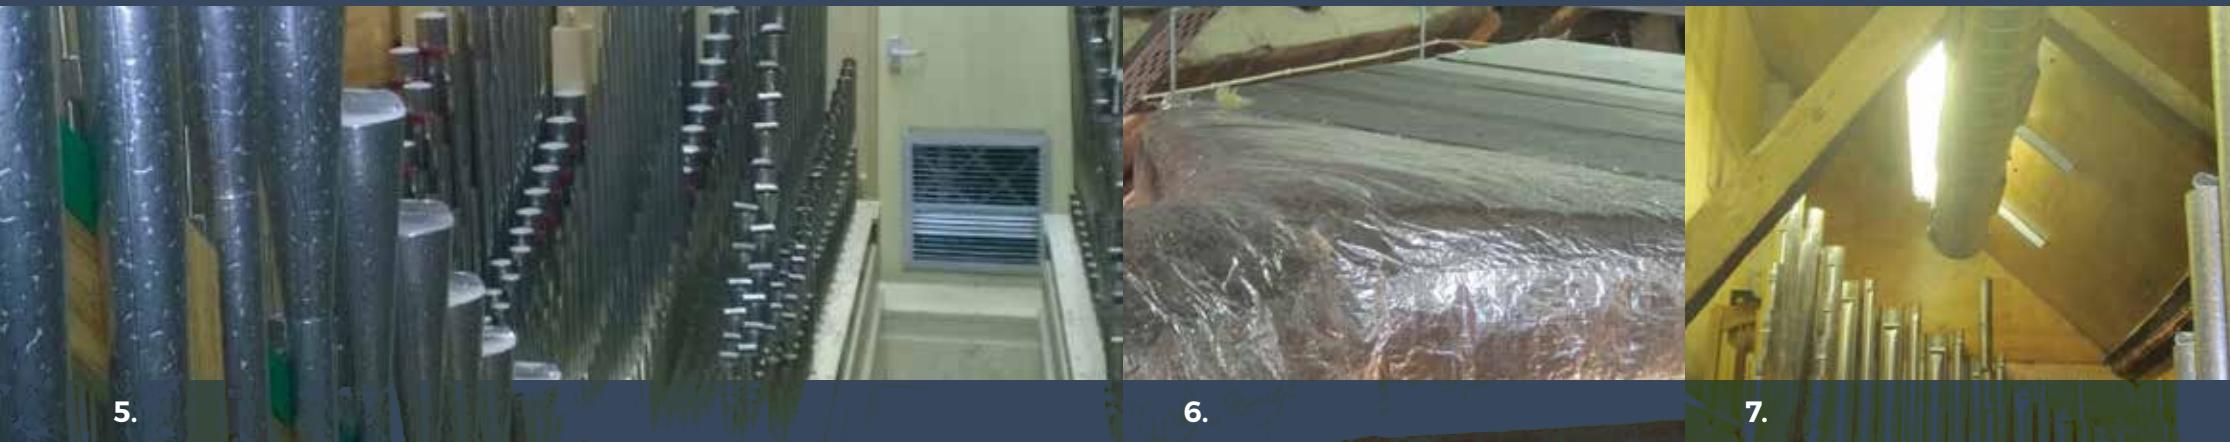
- 5.** The Organ Loft prior to Oakland's installation. Note the door to the plant cannot be used!
- 6.** Oakland's finished installation
- 7.** Pipe room ducting

Rear access was made via the existing wooden wall of the rear loft area so access to change the filters could be gained without entry by engineers into the sensitive and delicate Organ Pipe area. This unit would allow cooling down to 18°C with the ability to offset the sensor on the unit so cooling to 16°C would be possible.

We also re-routed the return ducting (previously going through the door) to the area above the door, thereby returning the use of the door for easy access to the new installation. All ducting in the plant area was insulated for efficiency and new supply ducting was fitted to take the conditioned air and deliver it evenly, at high and low levels thereby providing the most even temperature spread.

A new 4" Fan was supplied and fitted to bring outside fresh air into the return ductwork. This fresh air allows the organ loft to be slightly pressurised, pushing any dust laden air away from the organ loft and ensuring the cleanest of environments in the loft.
